CODY KILGORE UNIFIED SCHOOLS

Public Information Meeting
Thursday, June 3 @ 7pm

Facility Audit Findings (High School)

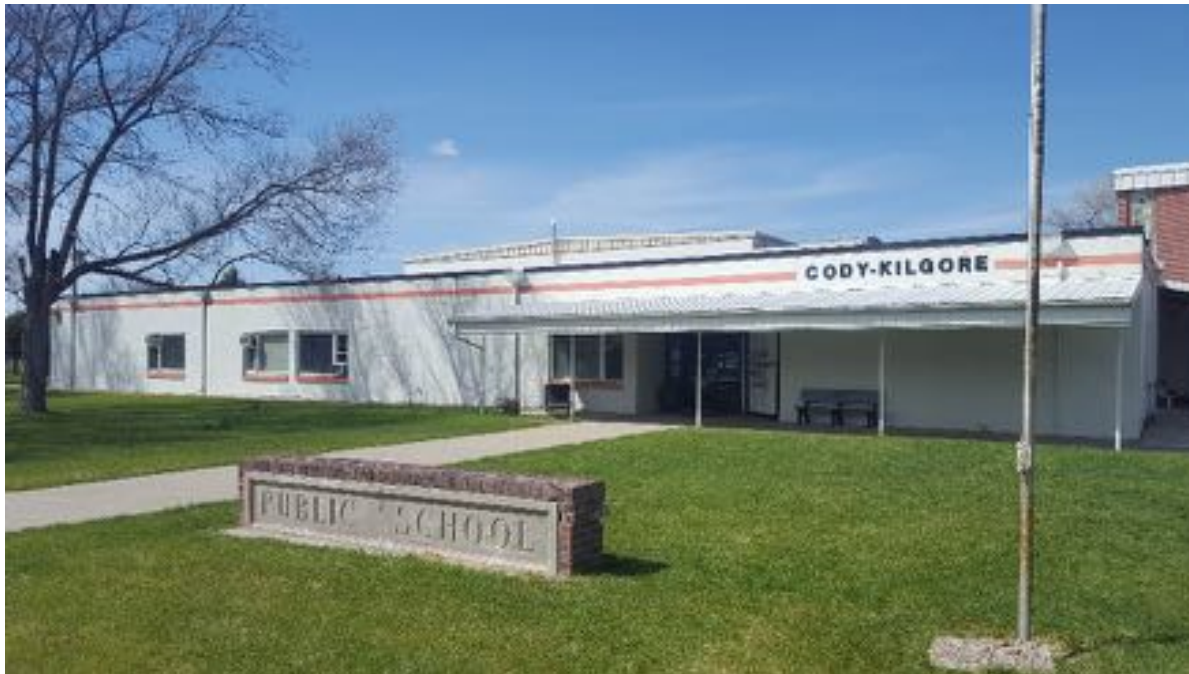
- Two existing hallways do not meet current fire code and safety standards (to the library and to music room/locker rooms)
- Interior classrooms require either egress or fire sprinklers. We have 4 classrooms that do not meet these safety codes.

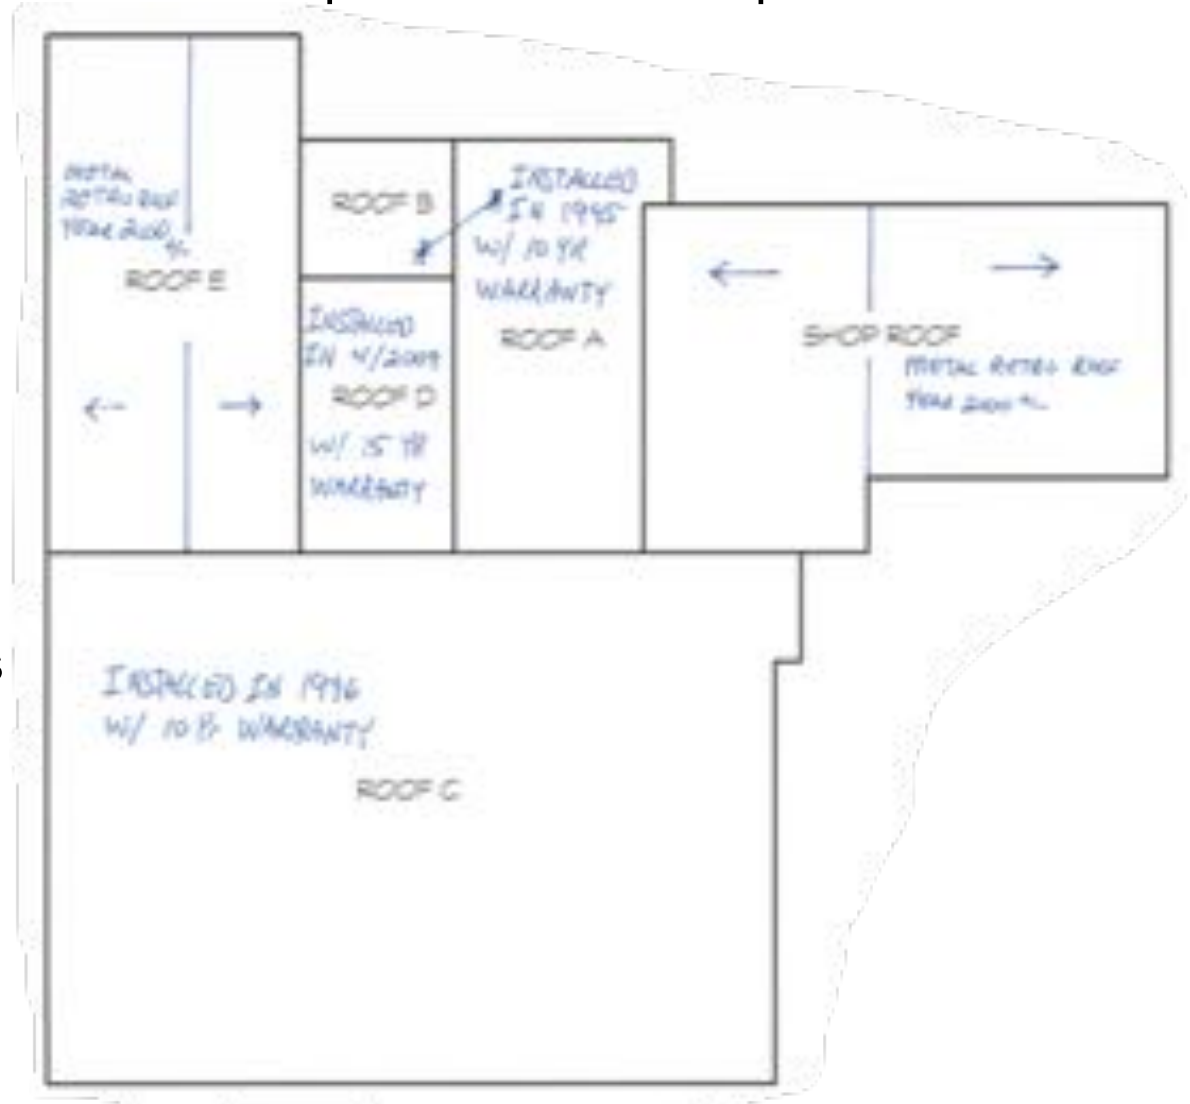
- Two roofs are 12 years over warranty and at capacity for drainage
- One roof (main part of building) is 11 years over warranty and is in most need of repair (some areas have been patched with multiple leaks found in building)
- One roof still has 7 years of warranty remaining and is in good shape (over locker rooms)
- Gym and shop roofs (warranty unknown) are in good shape
- Canopies at all entrances need to be taken down or replaced as they don't meet code

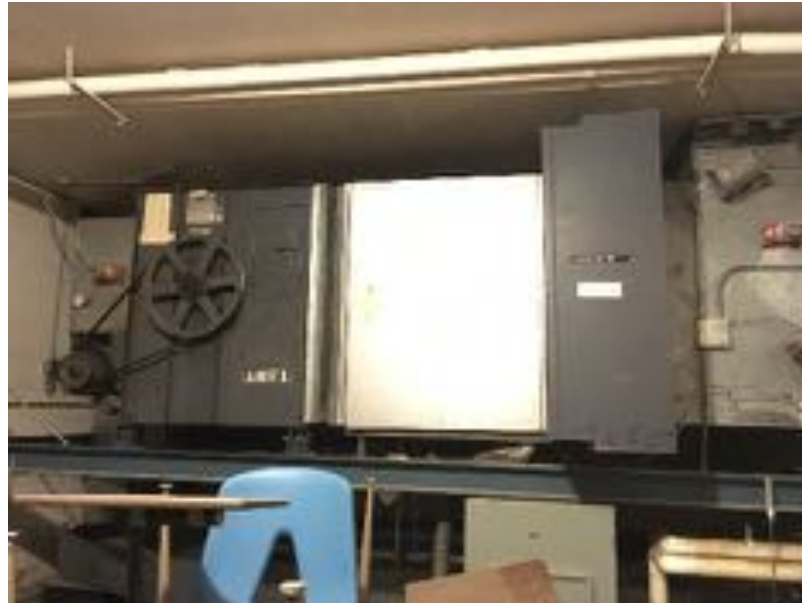
- HVAC units are in marginal condition

- HVAC is in marginal conditions and recommend upgrading and adding air
- Plumbing is ok but all restrooms and locker rooms need updated to meet current ADA standards. All water heaters need to be updated.
- Electrical service equipment needs to be replaced.

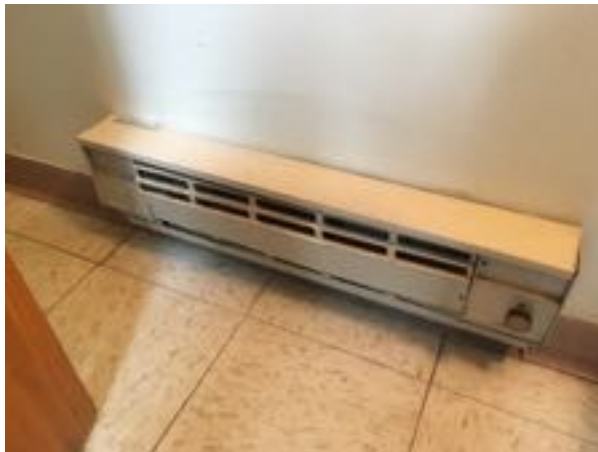
- Pneumatic Classroom Temperature controls are non functioning
- Base board heaters are in marginal condition

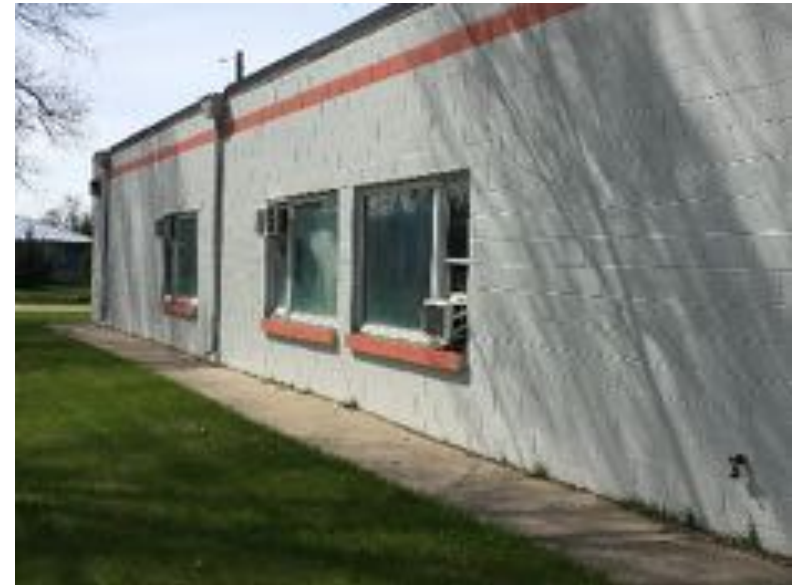
Photo 6

- Window air conditioners are noisy, inefficient and can overload existing electrical circuits

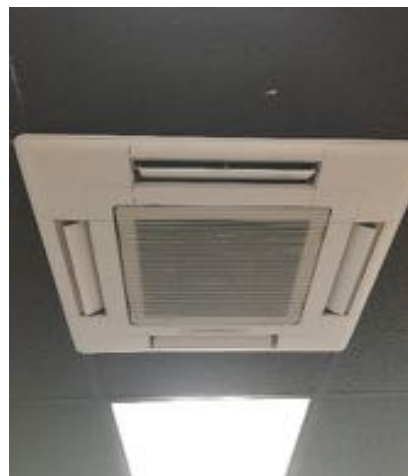
Photo 2

- Split Duct Systems have been installed to help with A/C and heat for interior classrooms, but still have major climate control issues.

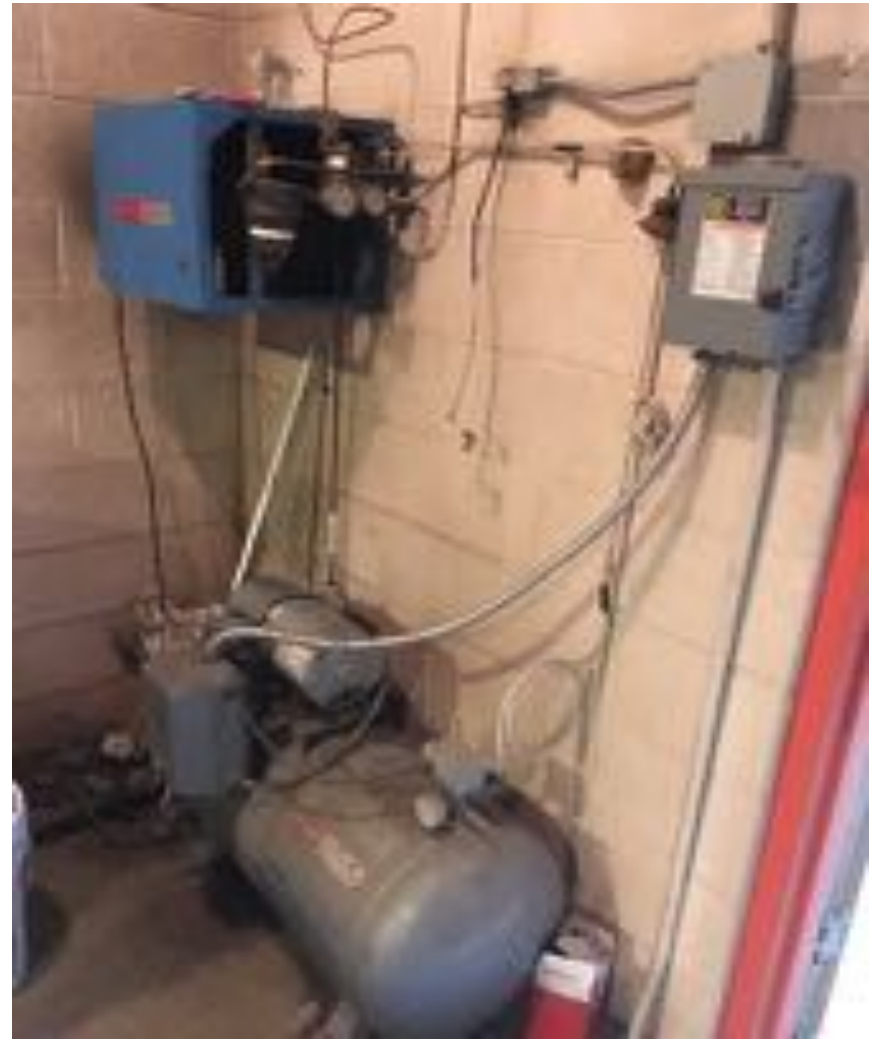
Photo 7

- Pneumatic control systems are an obsolete technology and difficult to maintain and repair. The existing control system is in poor condition and is not reliable.
- Duct work is in good condition

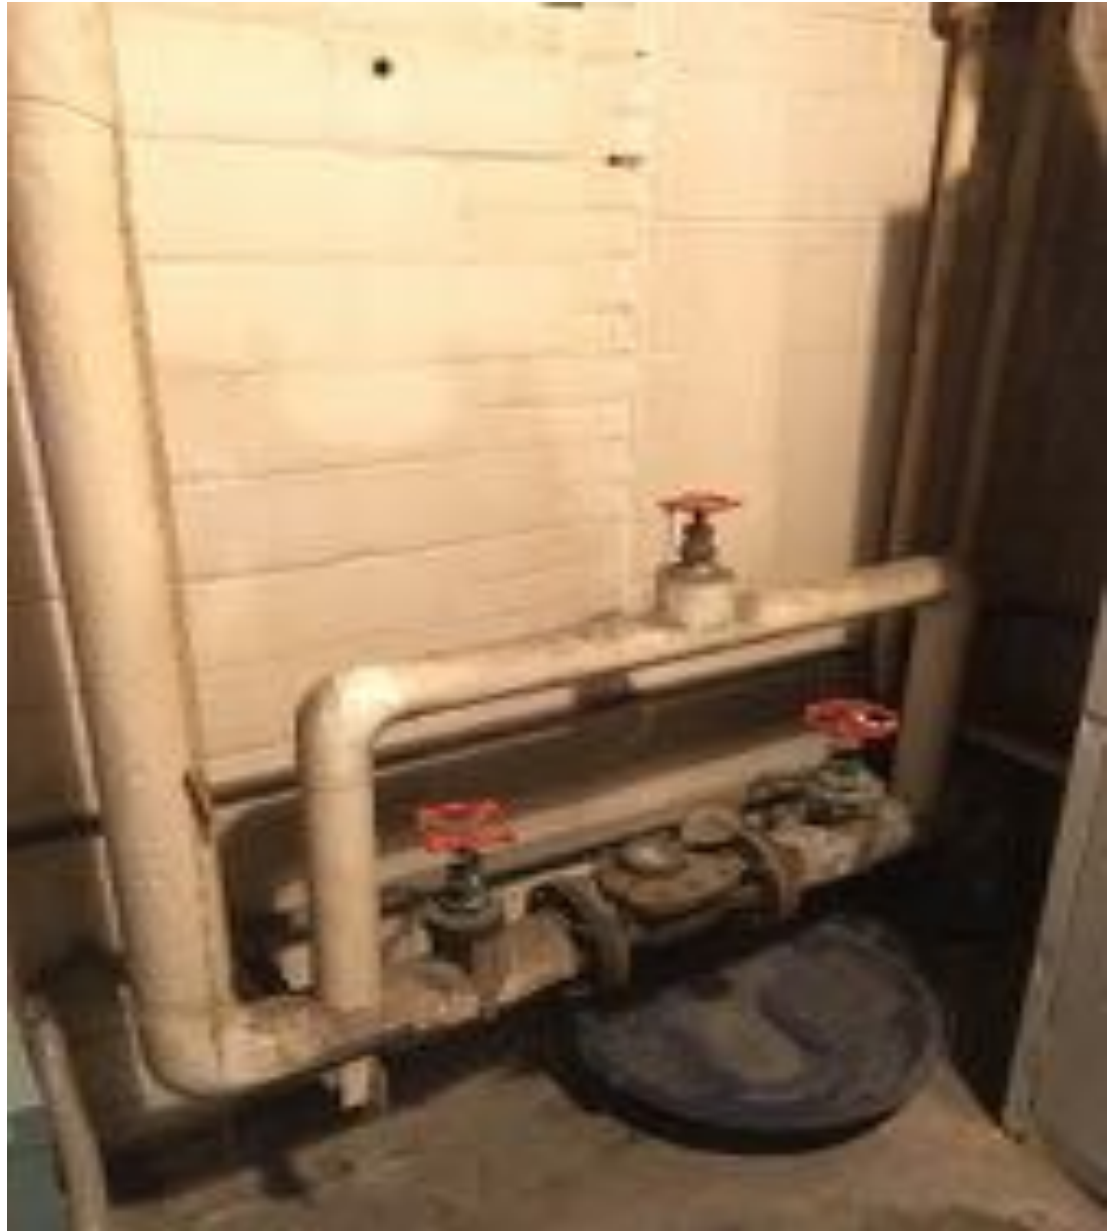
Photo 8

- Main water service line does not have a backflow prevention device. Main valve appears to be corroded and in poor condition.

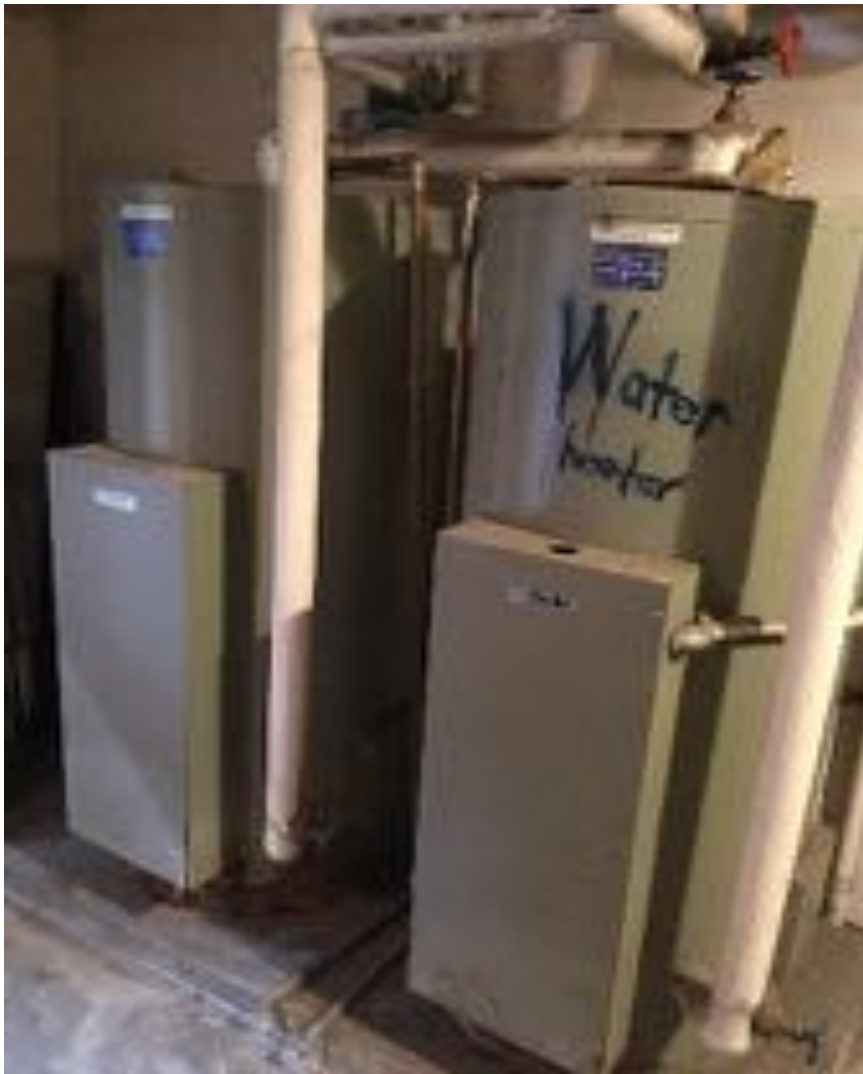
Photo 9

- Water heaters are in poor condition and are showing significant signs of corrosion.

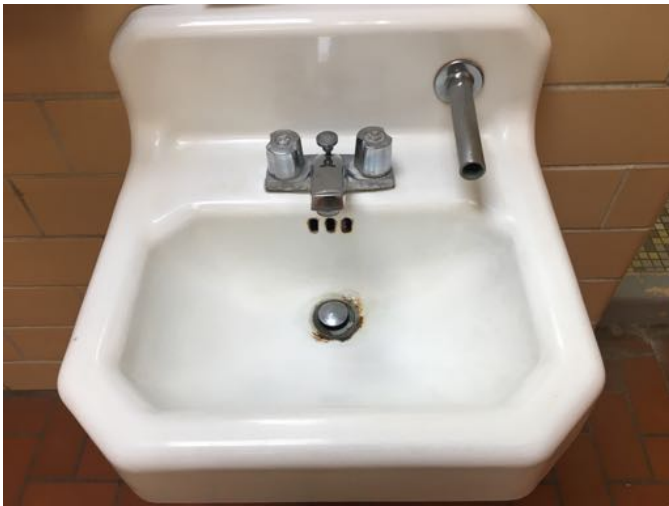
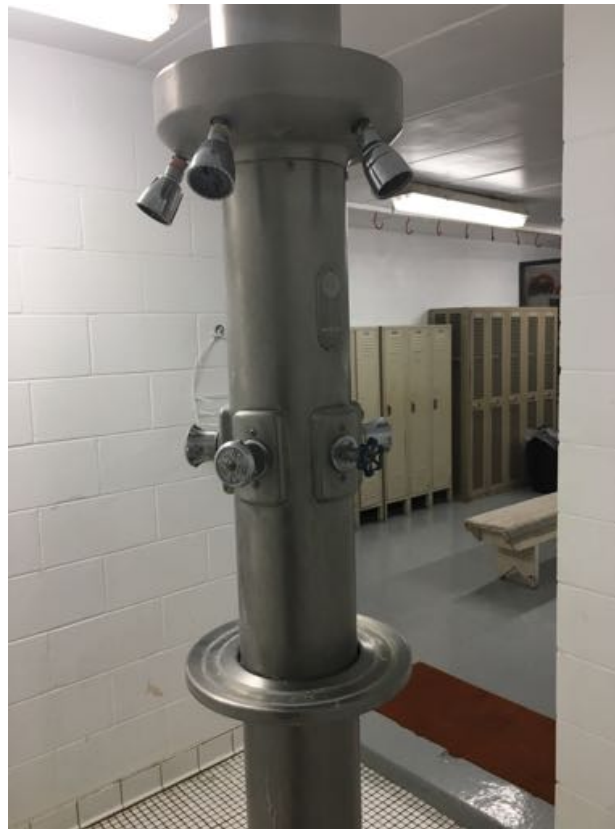
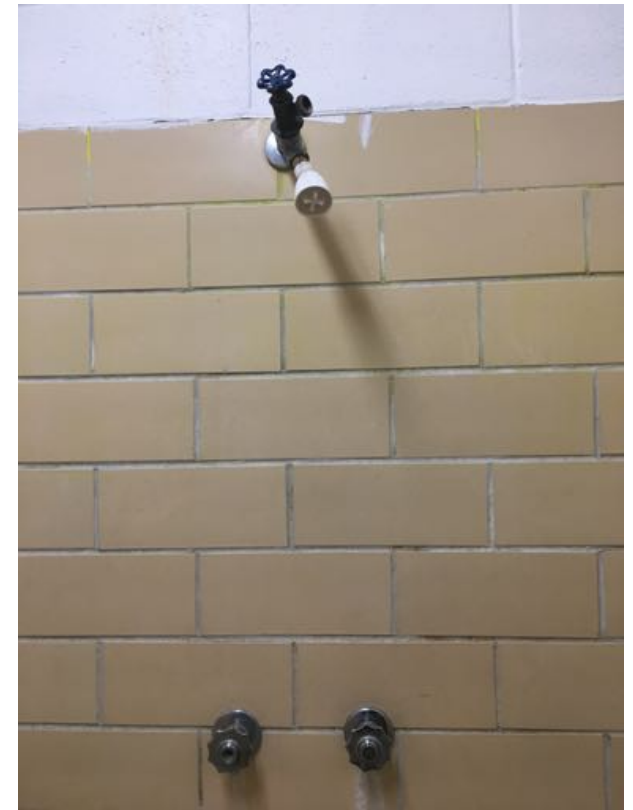
- Plumbing pipes are in generally good condition and are original to the building
- Plumbing fixtures throughout the building are in marginal or poor condition. A complete remodel of all restrooms and locker rooms including new plumbing fixtures and updates to meet current ADA standards is recommended.

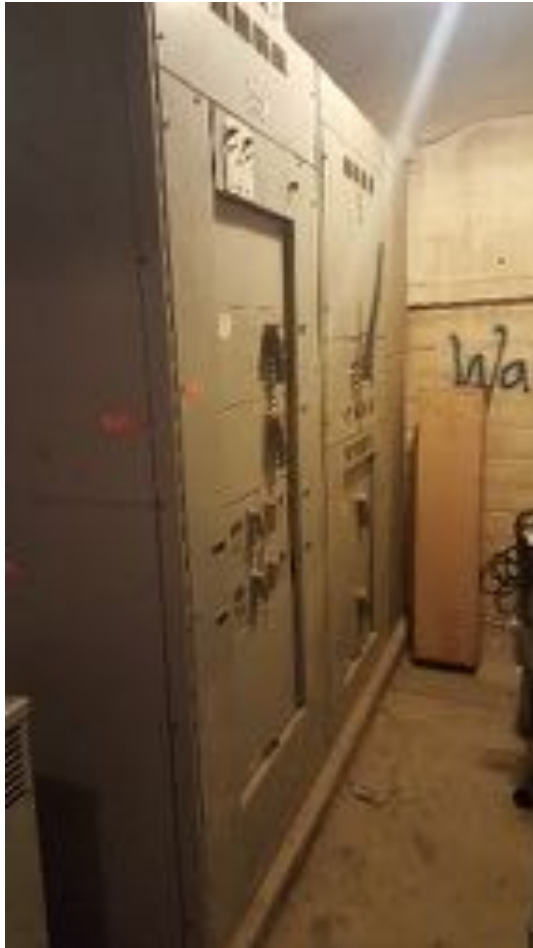
Photo 19

- Building distribution equipment is aged beyond their useful life and parts no longer are available.

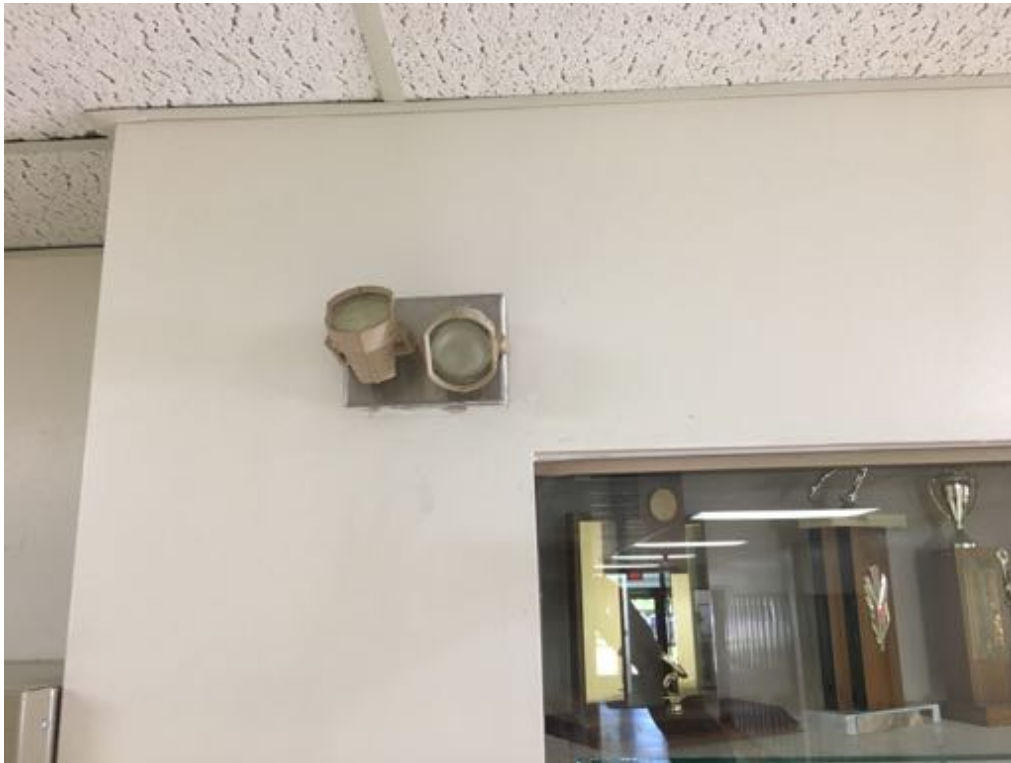
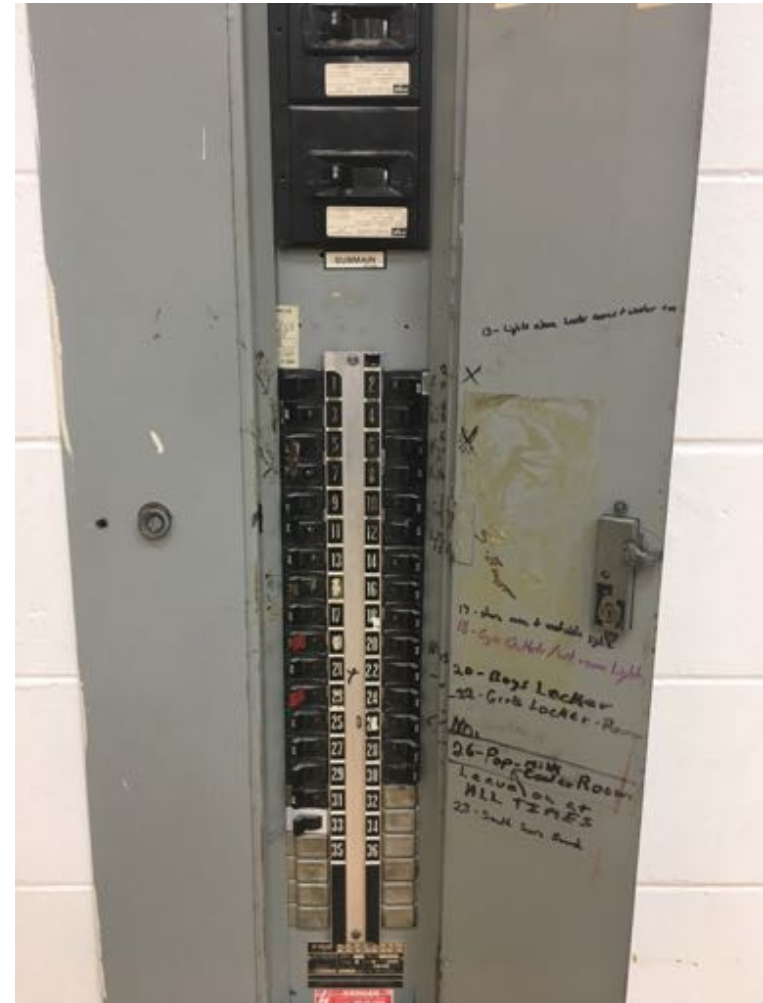
- Electrical panels within the school are aged beyond their useful life and parts are no longer available with no room for expansion.
- Emergency lighting is not functional and needs to be replaced (the district has had an electrical company look at it and it would need to be overhauled)

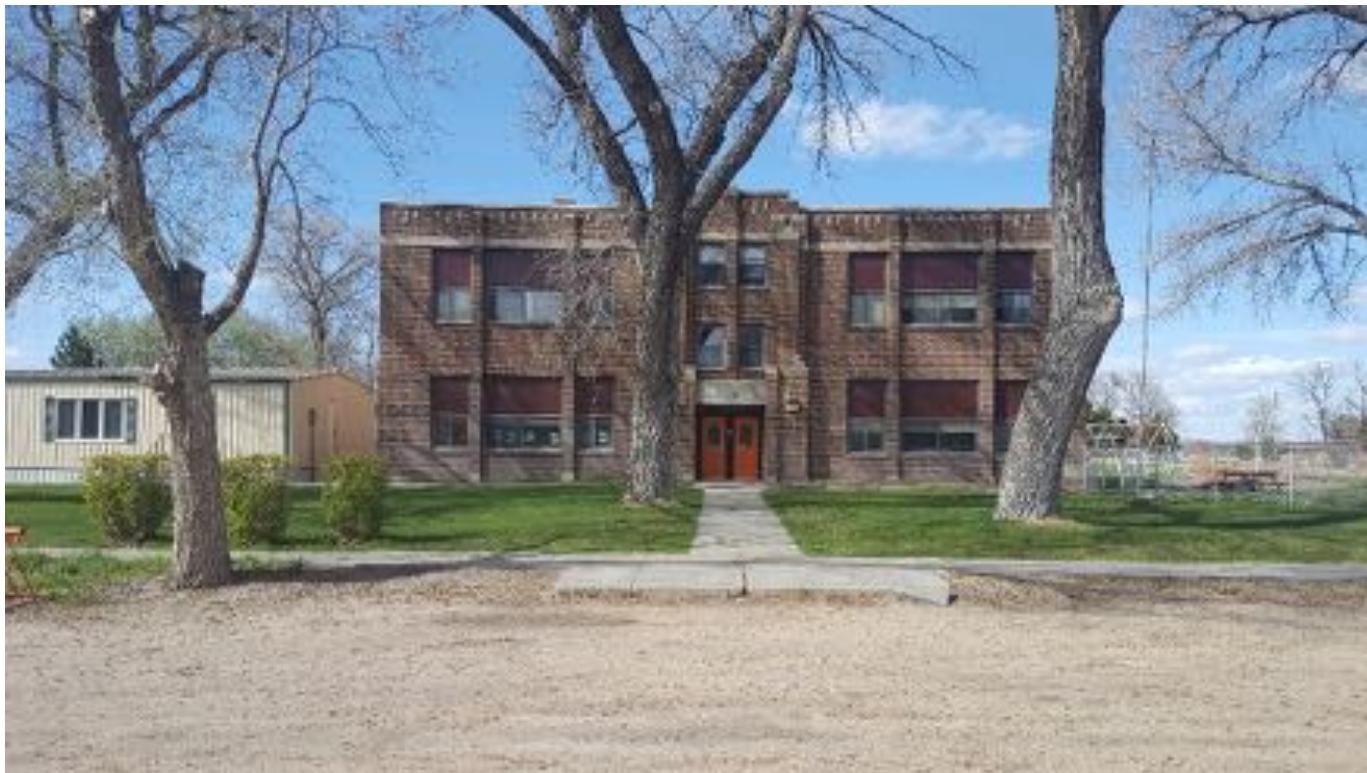
- In general the entire building, including the gym, does not meet any of the regulatory codes that govern educational facilities in the state of Nebraska.

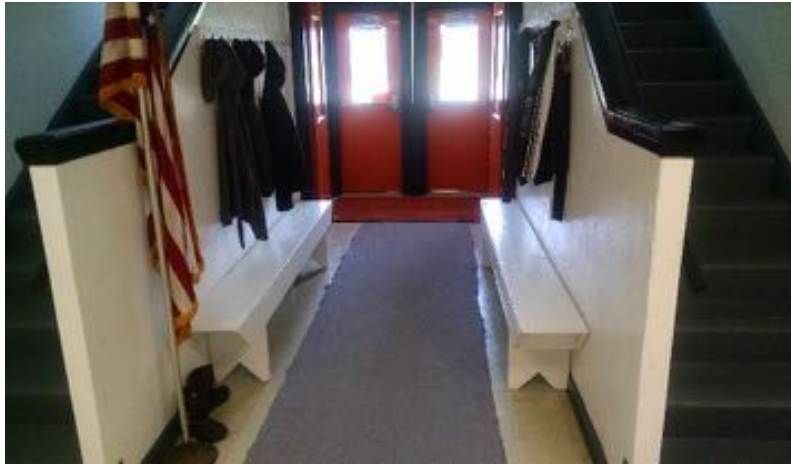
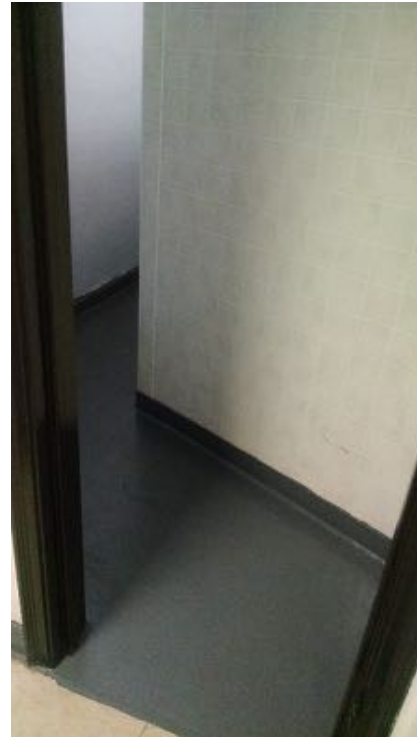
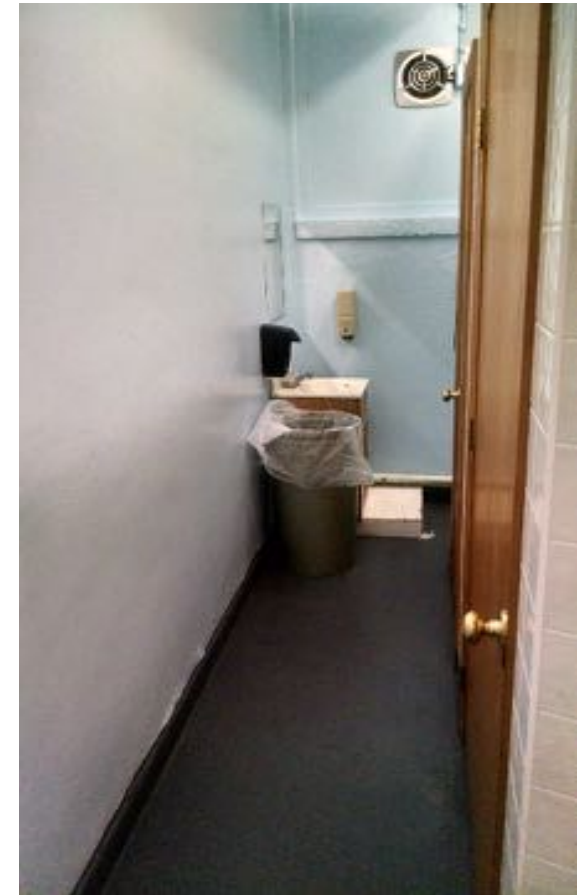
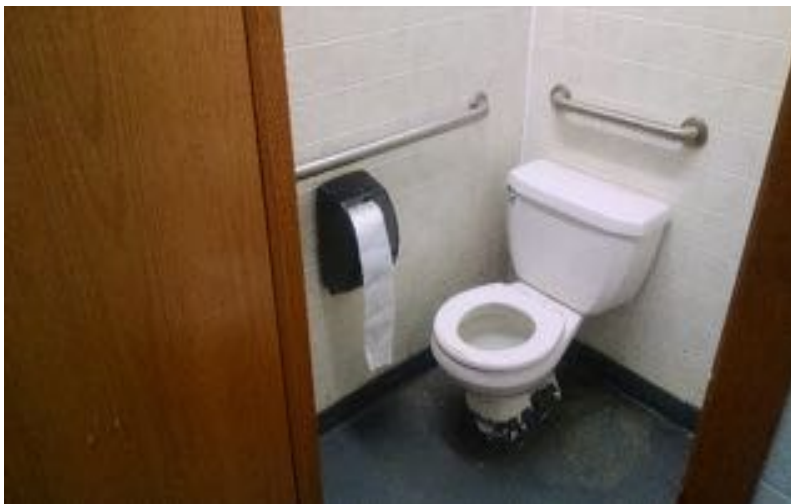
- All entrances are not ADA compliant. Main building doors are too narrow and cottage access don't have ramps. Bathroom entrances and stalls are not ADA compliant. Entrances to the stage/cafeateria are not ADA compliant.

- All new HVAC
- Complete replacement of all plumbing
- Life Safety and Fire Safety are concerns and a sprinkler system is recommended for the entire building.
- Electrical distribution is past its useful life and requires being replaced
- Lighting upgrades are recommended for energy savings
- Bring the building up to ADA code compliancy

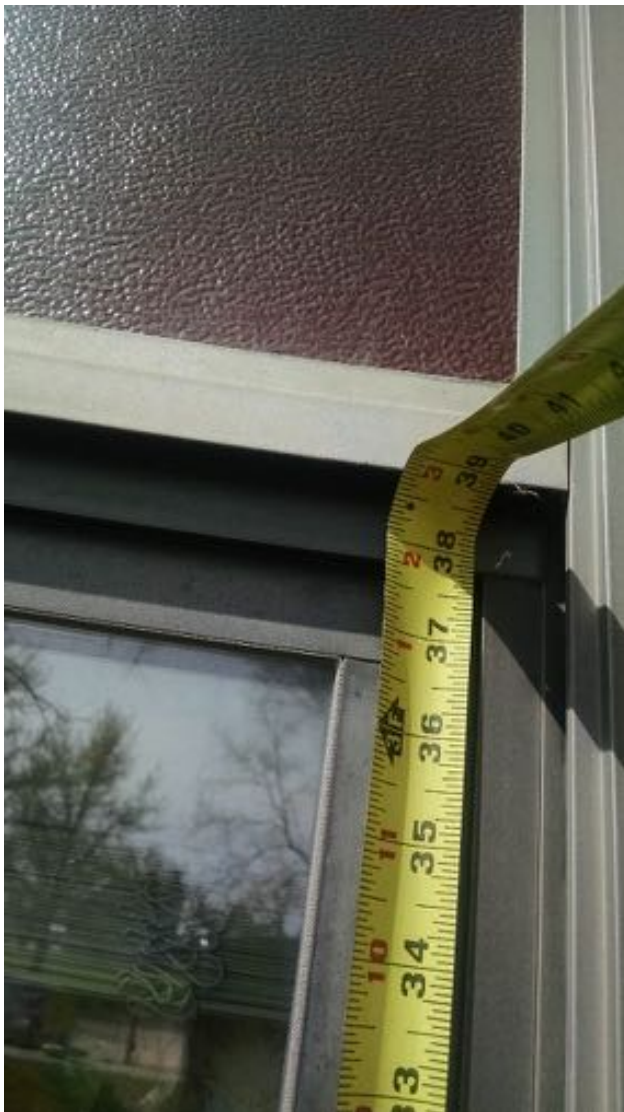
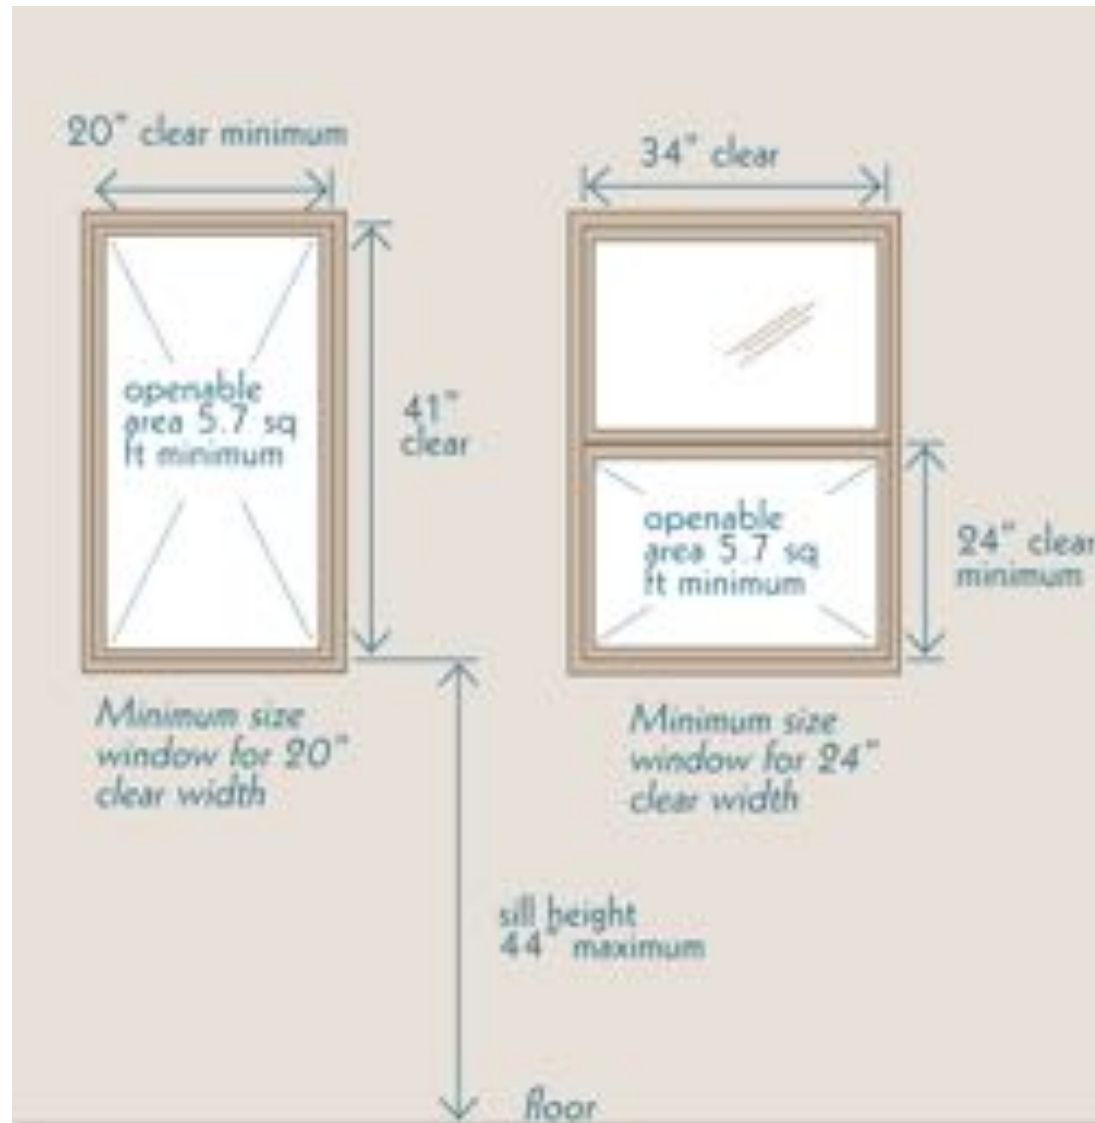
- No egress in any classroom meets fire code. All classroom windows are too small and latches are too high for fire escape and code compliance.

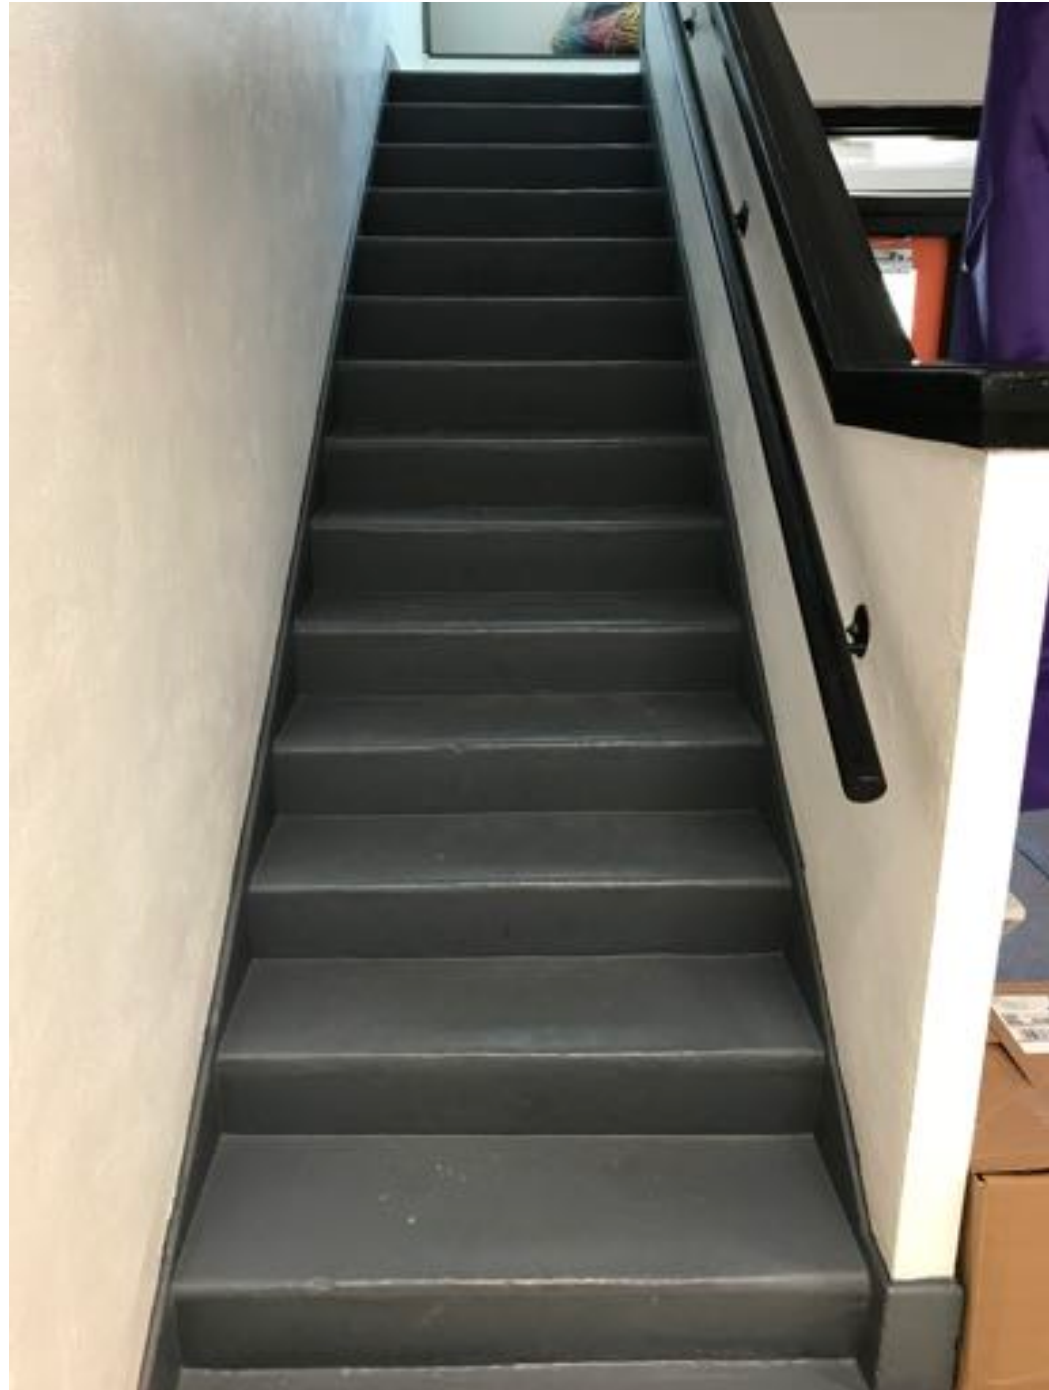
- No stairs (specifically stairwells) meet fire and safety codes

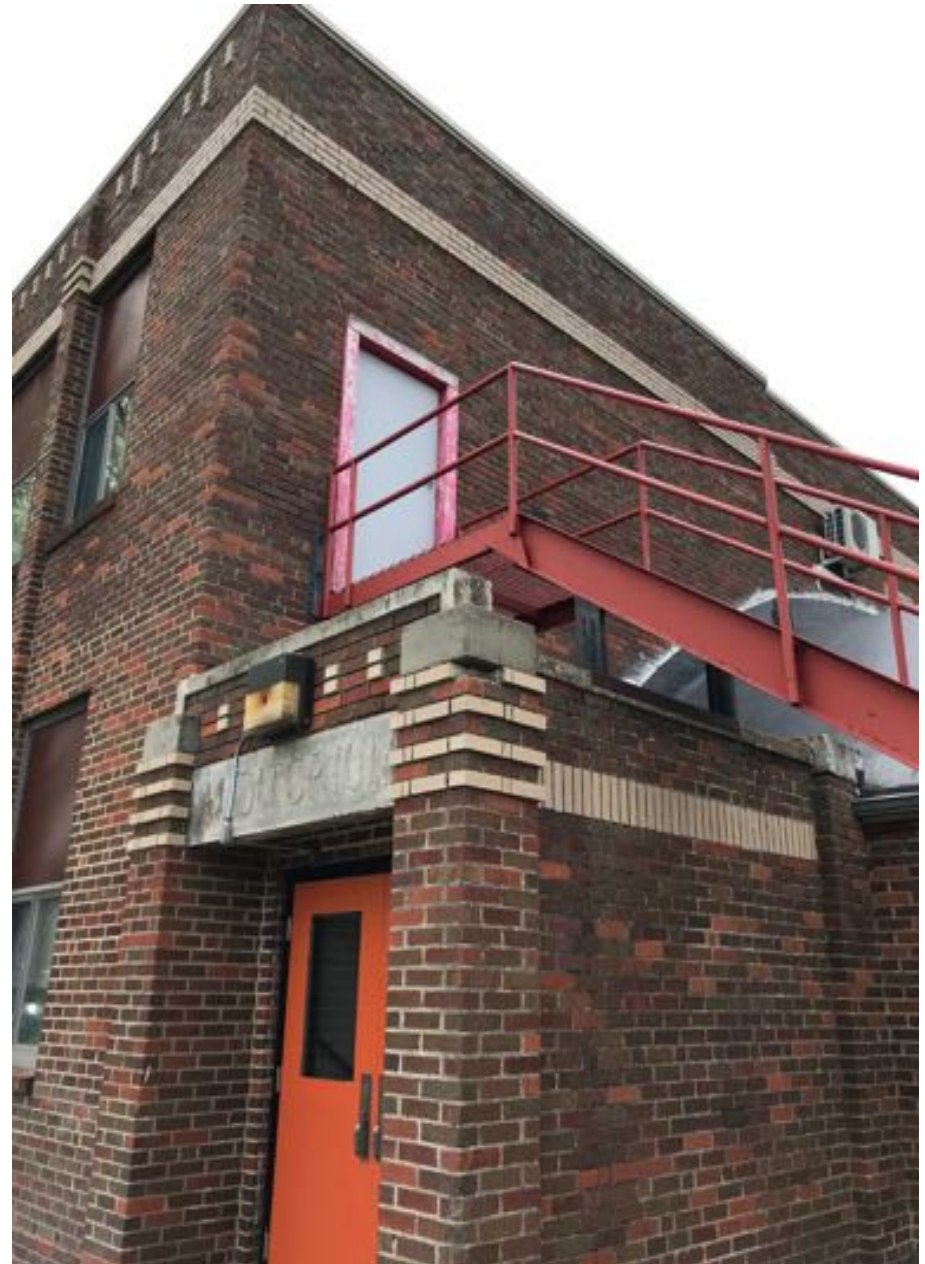
- Egress is not suitable for fire escape.
- Fire department doesn't have equipment for 2nd floor access in the case of a fire
- Only one exit on the Northeast corner of 2nd floor.
- No tornado shelter in the building or near the building.

- At least one stairway is to be no-communicating (meaning the stairway needs to exit directly to the outside and not open up to the level below. In addition, this stairway is to be protected by the weather (covered at a minimum and preferred to be enclosed in the fire rated structure). If one of the exits in an upper level is required to go through an occupied room, then this room is required to be large enough to hold $\frac{1}{2}$ of the “code certified” occupancy load of the entire level. In this building, the required occupancy (including the upper level Sped Room) for this room would be 70 ($\frac{1}{2}$ of the code allowance occupancy of 141 - per table 1004.1.1 of the 2006 International Building Code). The existing 2nd stairs and route to the stairs do not meet code.

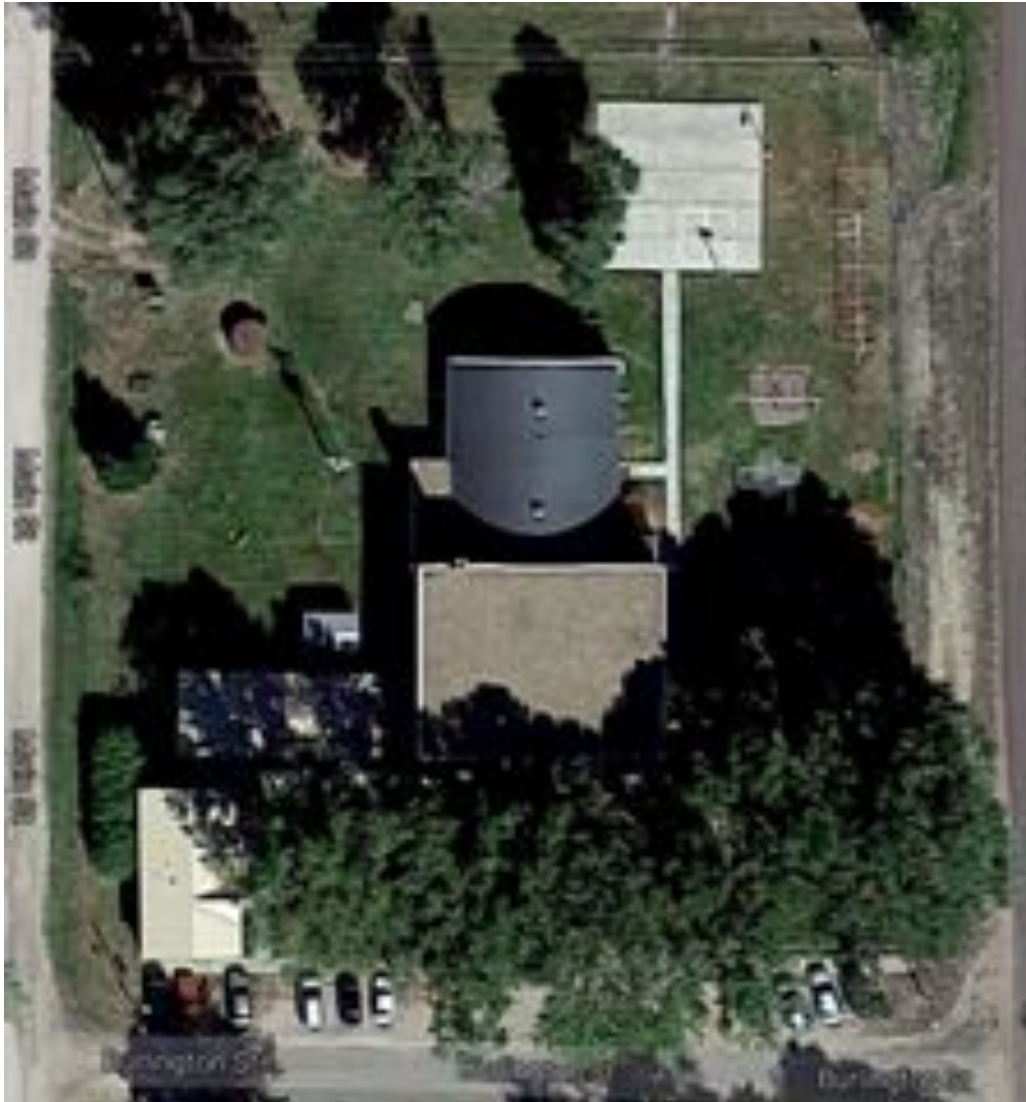
- Both roofs are in good condition and still under warranty.

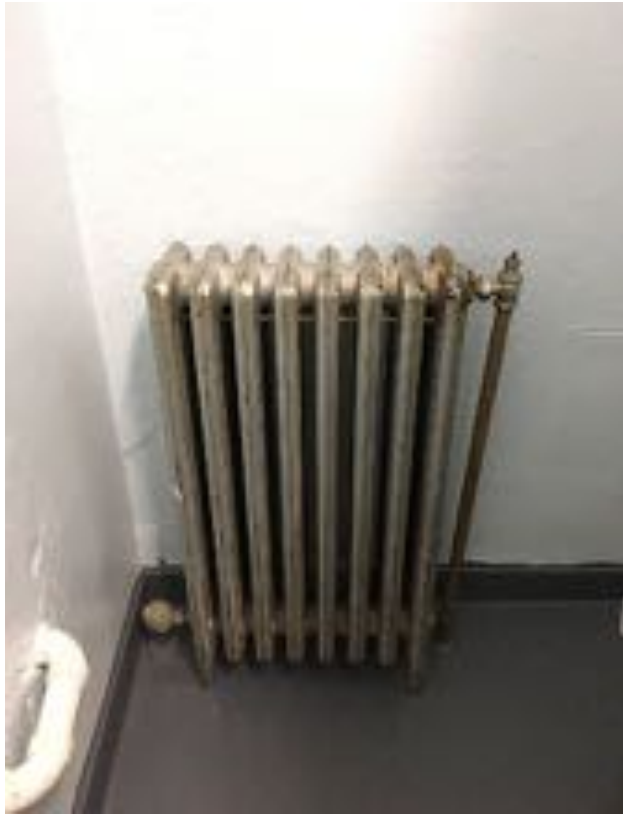
Photo 12

- All cast iron radiators and steam finetube heaters are aged and in poor condition.
- Temperature controls are adjusted at each piece of equipment. The current controls are ineffective at promoting occupant comfort.

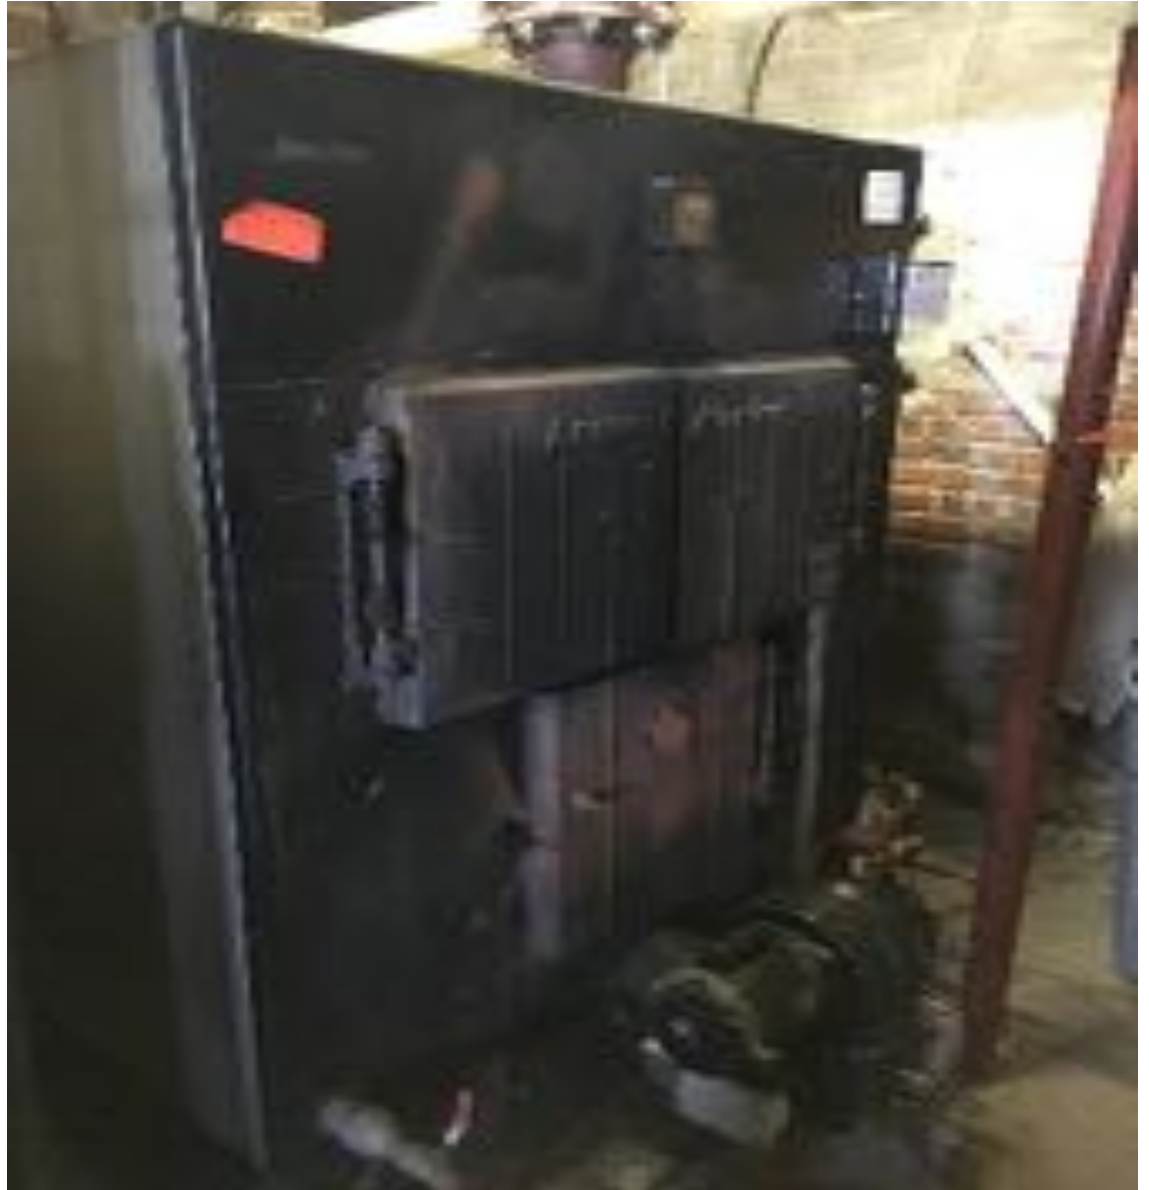
Photo 11

- The boiler appears to be in poor condition
- The piping in the entire building is in marginal condition. Piping in the main boiler room is in very poor condition. Insulation is not installed on any of the piping through the building.
- Averaging 1 day of lost instruction annually to boiler malfunction (school closure)

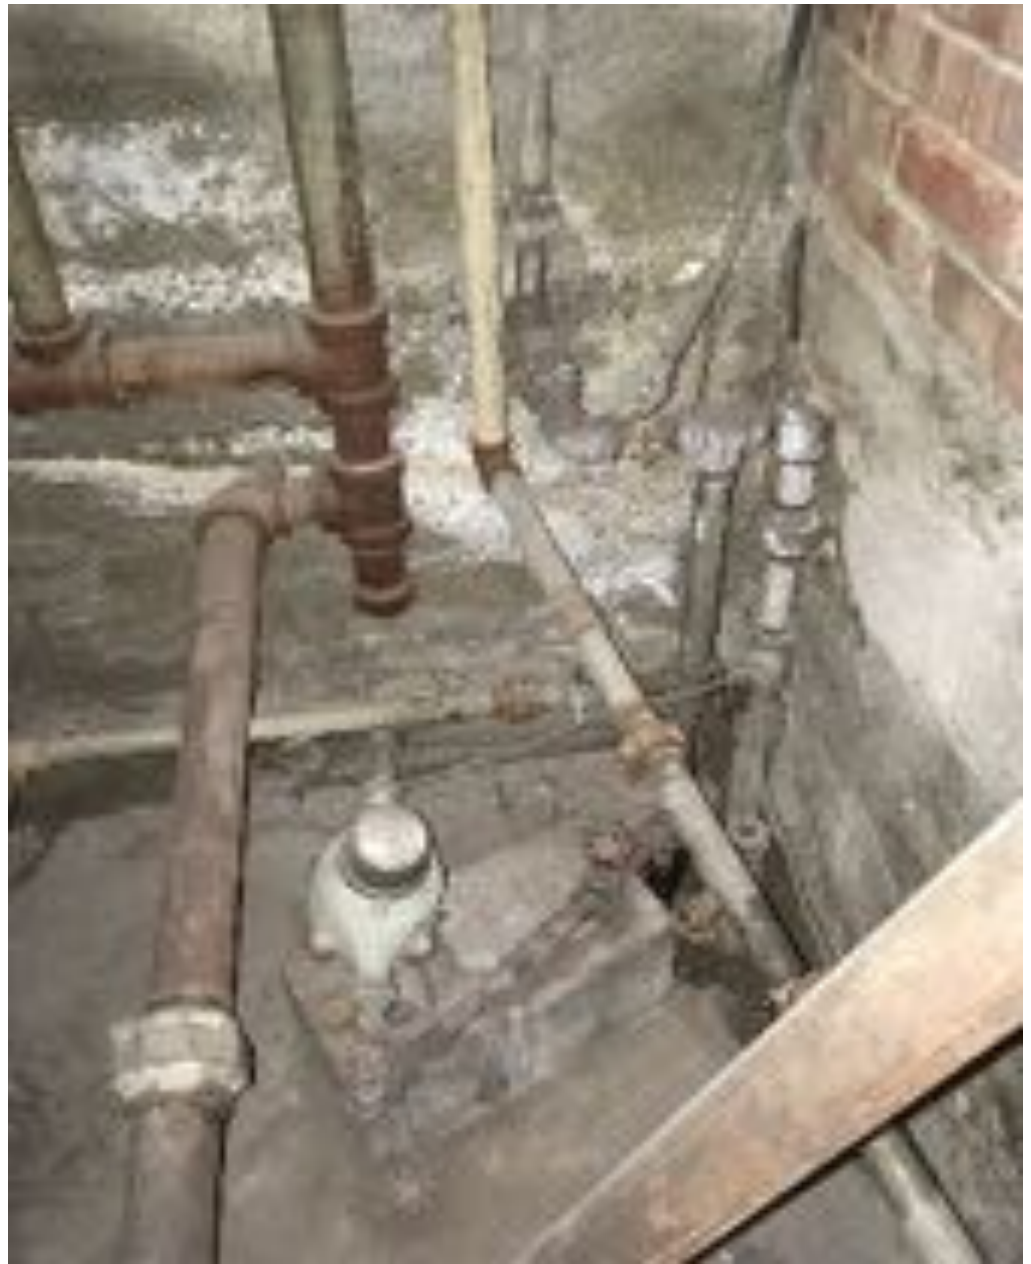
Photo 15

- 1" main line does not have a backflow prevention device. Piping is corroded and in poor condition.
- Generally all piping in the entire building looks to be in poor condition and needs to be replaced.
- Septic tank failure. Second semester no east side bathrooms (both floors) or functioning drains in kitchen.
