CODY KILGORE UNIFIED SCHOOLS

Public Information Meeting
Thursday, June 3 @ 7pm

Facility Audit Findings (High School)

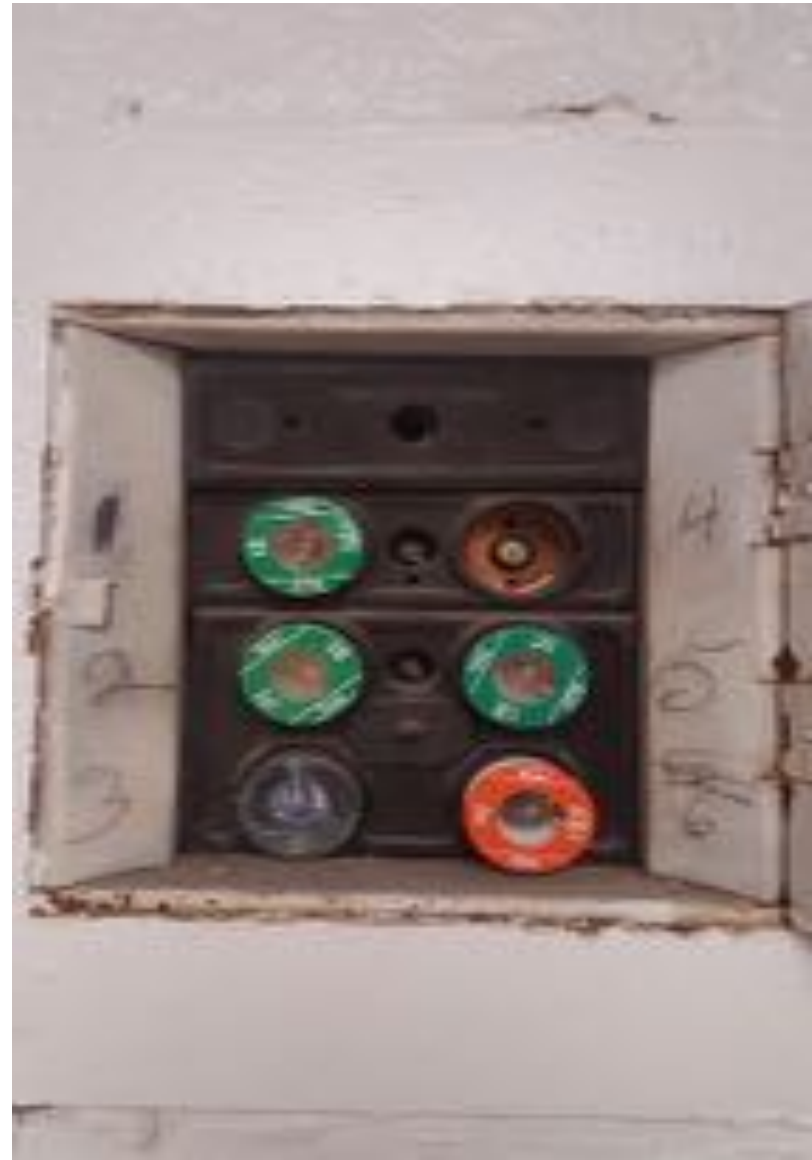
Photo 28

- Electrical service panel was installed in 1995. The panel is in good condition and has about 10 years of life remaining in the current condition of the school.
- Other panels throughout the school are aged beyond their useful life and parts are no longer available. Existing electrical panels, besides being beyond their age, do not have any additional capacity to add anything to the building.

- All new HVAC
- Complete replacement of all plumbing
- Life Safety and Fire Safety are concerns and a sprinkler system is recommended for the entire building.
- Electrical distribution is past its useful life and requires being replaced
- Lighting upgrades are recommended for energy savings
- Bring the building up to ADA code compliancy

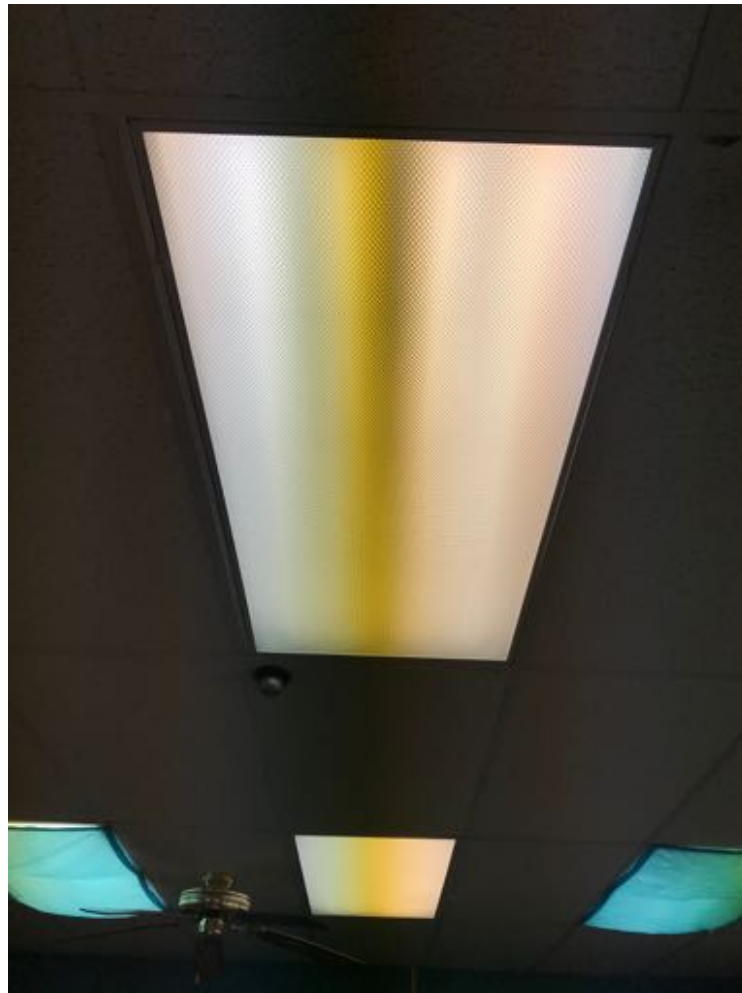
- As a whole, the majority of the lighting within the building is beyond its useful life and should be replaced.
- In addition to the light fixtures being beyond their useful life, generally most of the lighting within the building is 30% or more, less energy efficient than today's LED light fixtures.
